J & J PROPERTIES  
ROOF EVALUATIONS  
4201, 4130, AND 4128 N FIRST  
ABILENE TX 79603  
CENTURY FILE: 0107555  
HAAG FILE: 0111002404-120

Re: J & J Properties  
Roof Evaluations  
4201, 4130, and 4128 North First  
Abilene, TX 79603  
Century File: 0107555  
Haag File: 0111002404-120

Complying with your request, we inspected the roof coverings at the captioned locations to determine the extent of hail damage, if any. Our inspection was conducted on September 16, 2011.

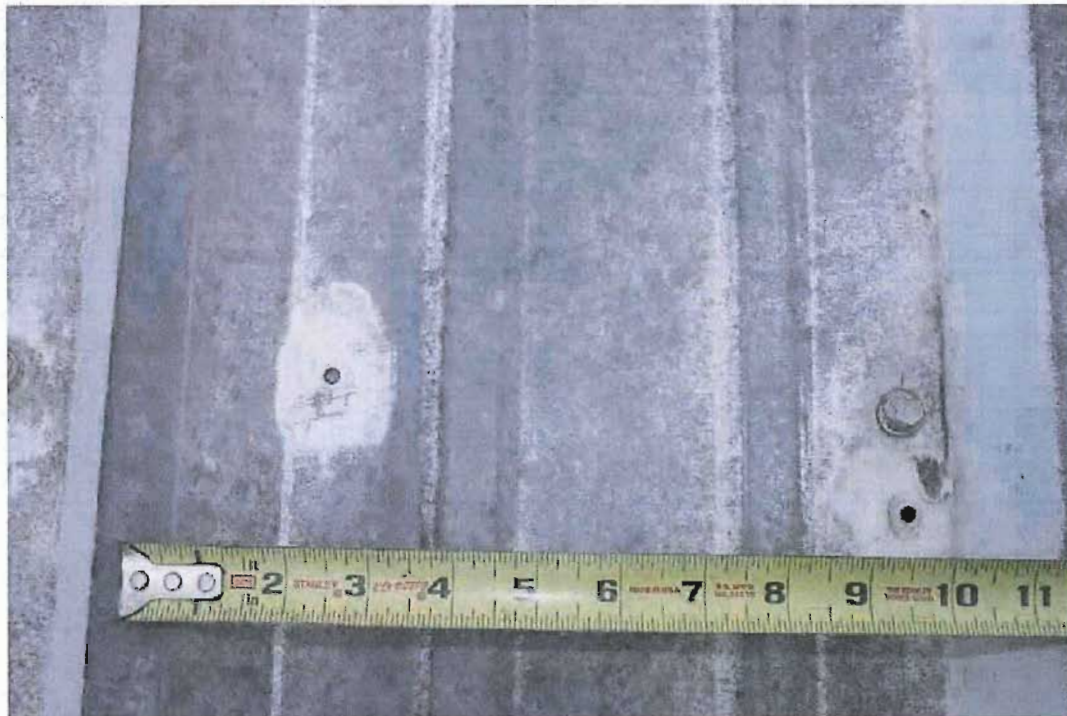
The metal roof at this location was in fair condition. The painted (white) surface was worn but there was no evidence of significant rust or other deterioration of the steel. There were a number of empty screw holes in the roof that would allow water entry. In addition, there were no closure strips along the eaves. Thus, we were able to insert a tape measure under the ribs. Water entry could occur if the gutters became full of water as the outside edges of the gutters were higher than the panels. Portions of the east gutter were clogged with leaves. Some foot-caused crimps were noticed in the ribs along the east edge of the roof. The crimps were narrow and deep, extending perpendicular to the panel ribs. Foot-caused crimps were located between underlying purlins. Some of the crimps had been caulked or covered with a panel piece and sealant. Two types of sealants had been applied over certain fasteners. Roof vents were not flashed correctly. There were no gaskets around the vent flanges. (Refer to Photographs 1 through 20.)

5. 4128 BLDG – Empty fastener holes in panels.

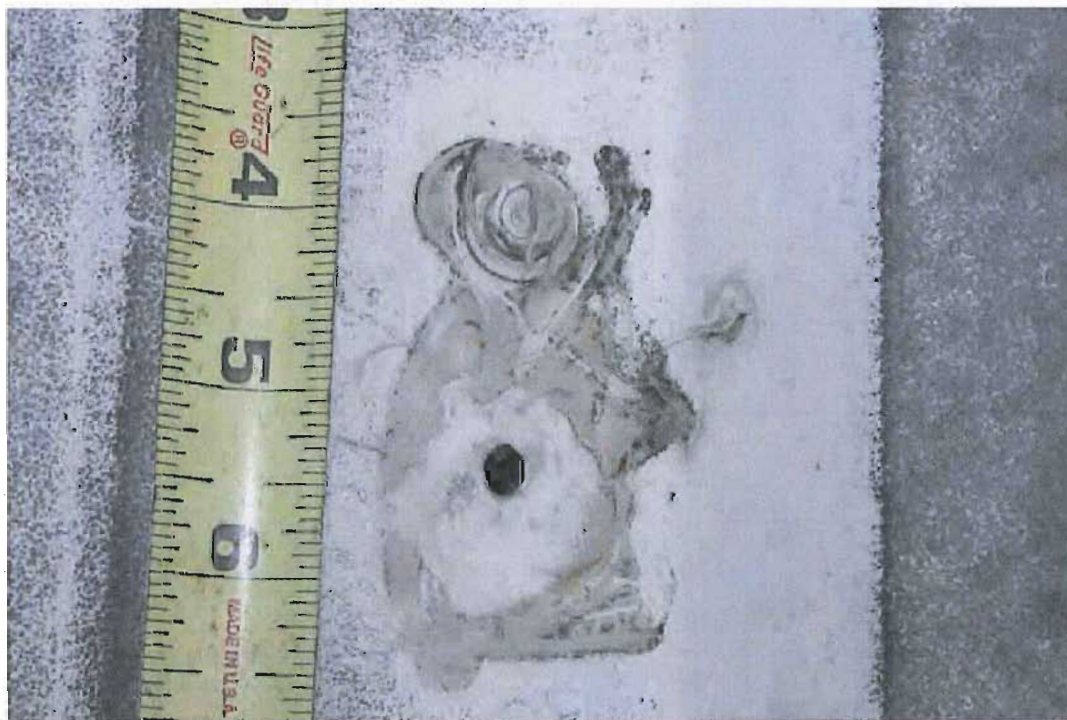
6. 4128 BLDG – Another empty fastener hole in panel.

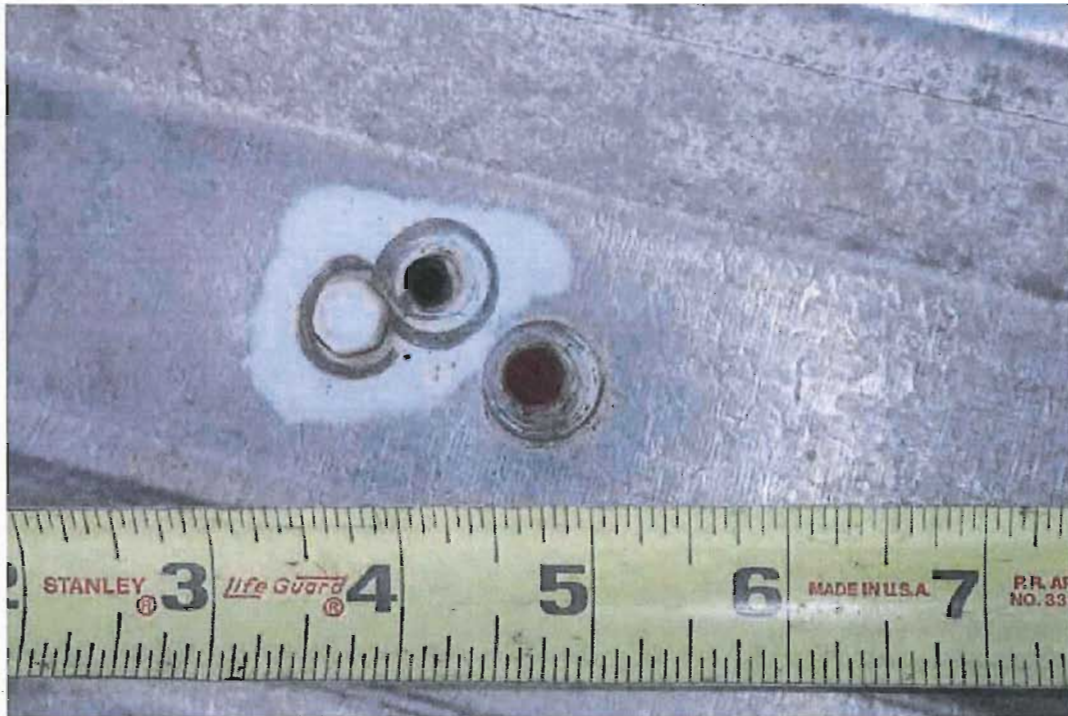
7. 4128 BLDG – Empty fastener holes in panels.

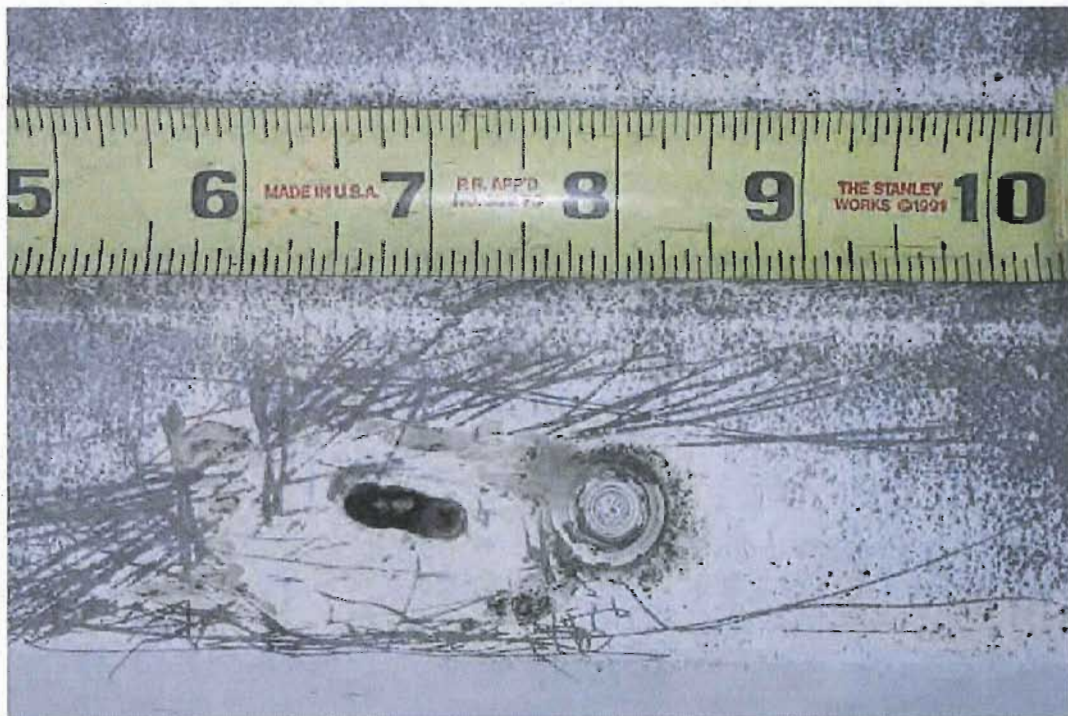
8. 4128 BLDG – Another hole in a panel.

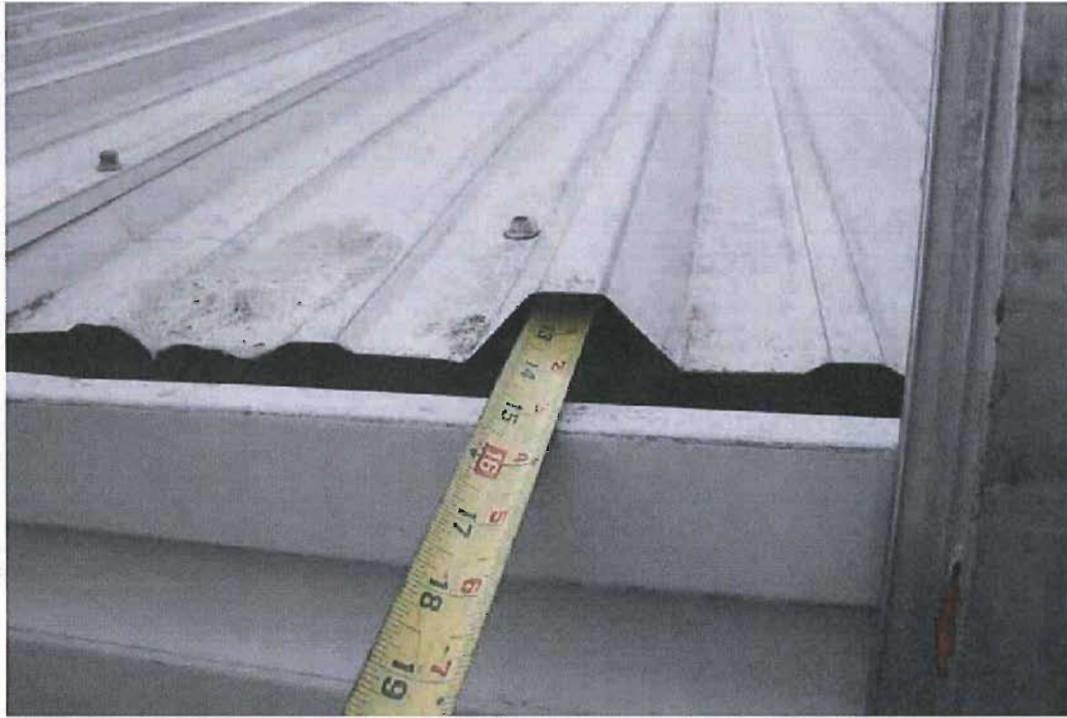
9. 4128 BLDG – Lack of eave closure.

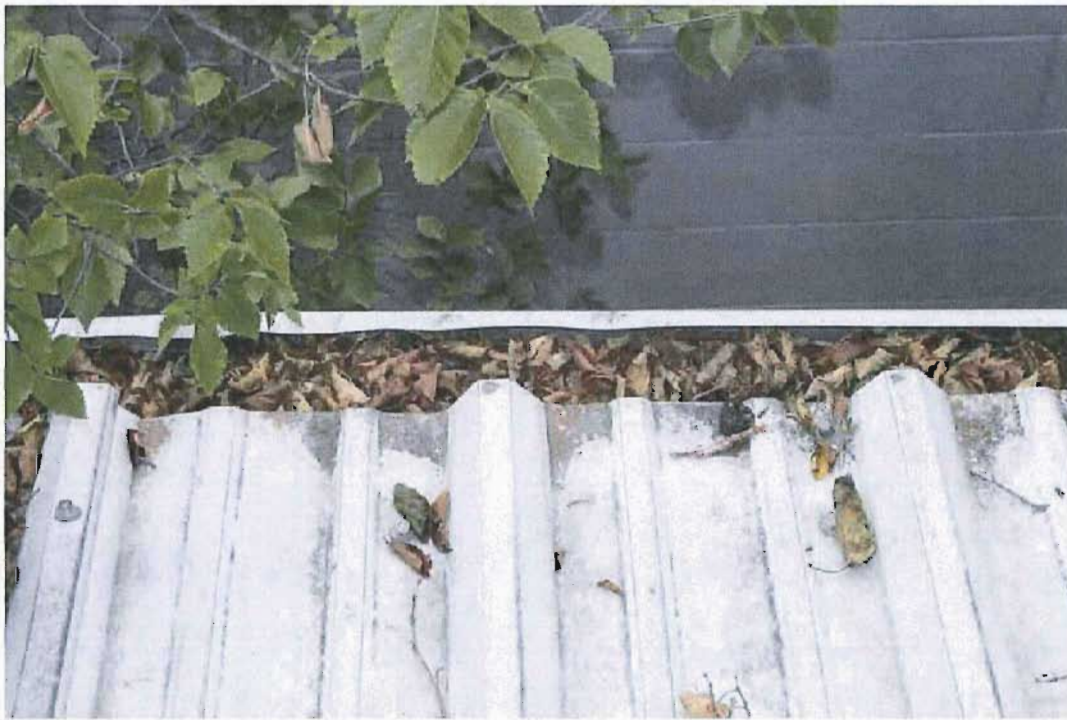
10. 4128 BLDG – Clogged gutter.

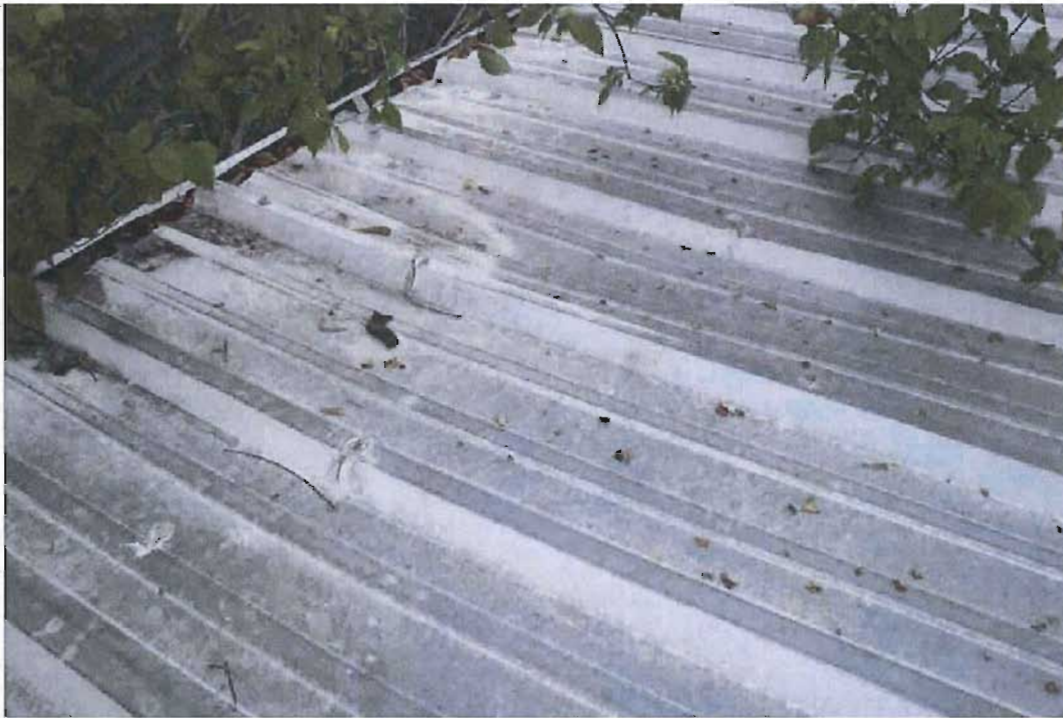
Metal panels initially were formed from flat sheets (coil stock) that were rolled through a series of dies that bent the metal into the desired profile. Such bending or denting of the metal actually increased panel strength. The radius of curvature in forming the panel ribs was more severe than the old hail-caused dents found to the ridge caps at the 4128 North First Street location. Also, foot-caused crimps in the panel ribs were more severe than the hail-caused dents.

11. 4128 BLDG – Foot-caused crimps in panel ribs.

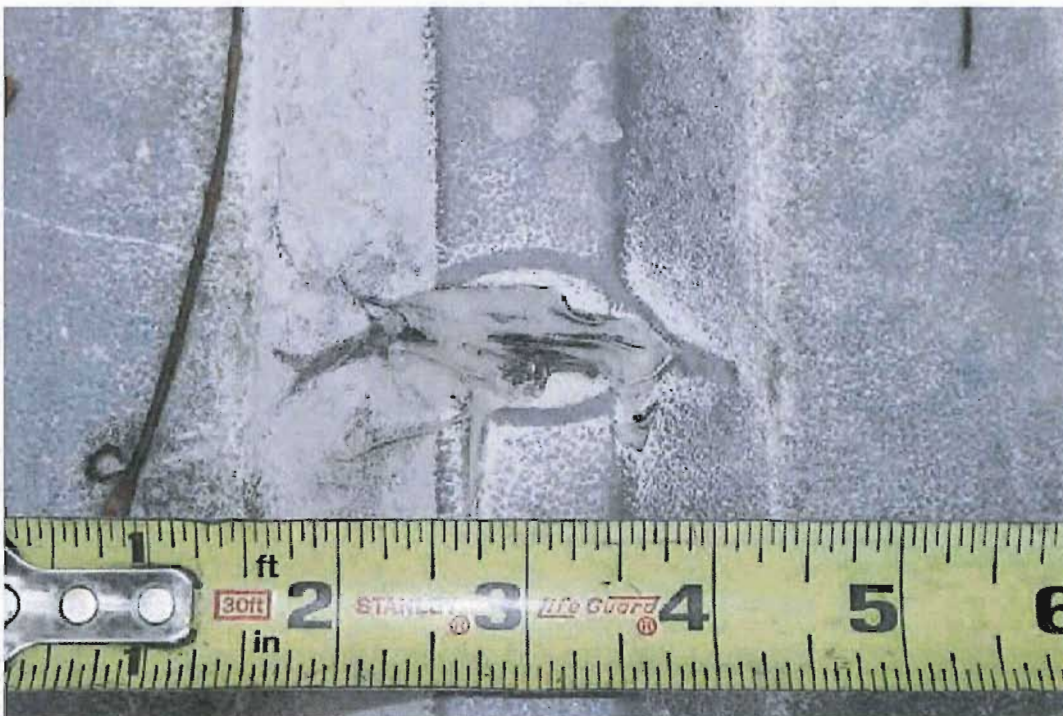
12. 4128 BLDG – Caulk applied to crimped rib.

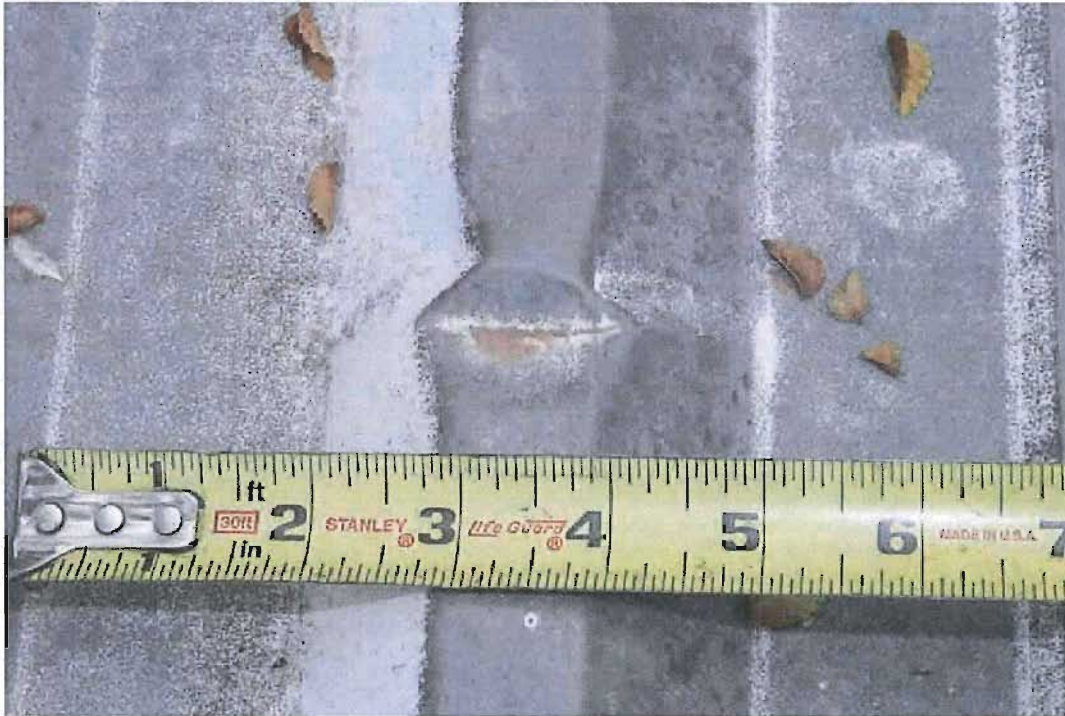
13. 4128 BLDG – Crimped panel rib due to foot traffic.

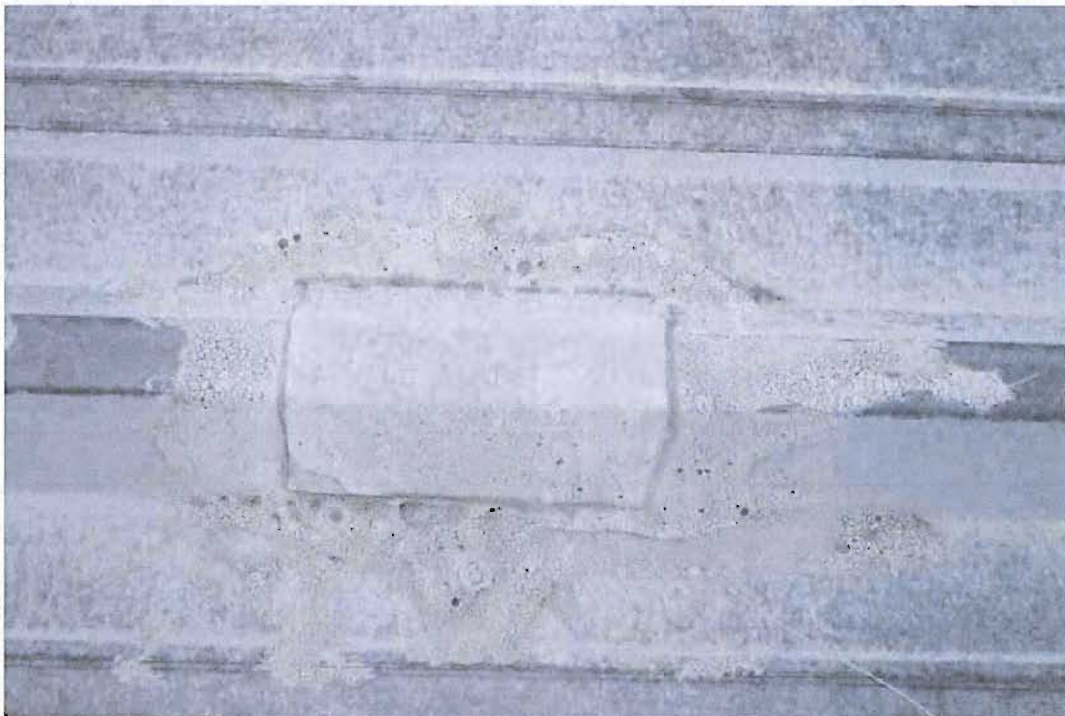
14. 4128 BLDG – Repaired rib.

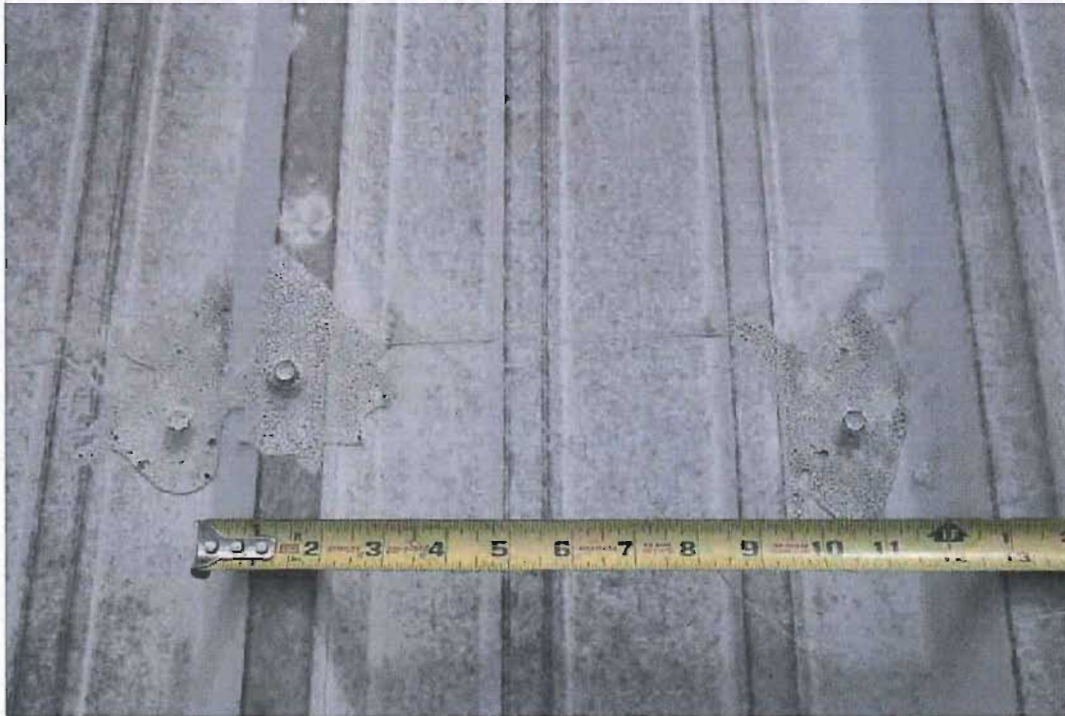
15. 4128 BLDG – Sealant applied to fasteners.

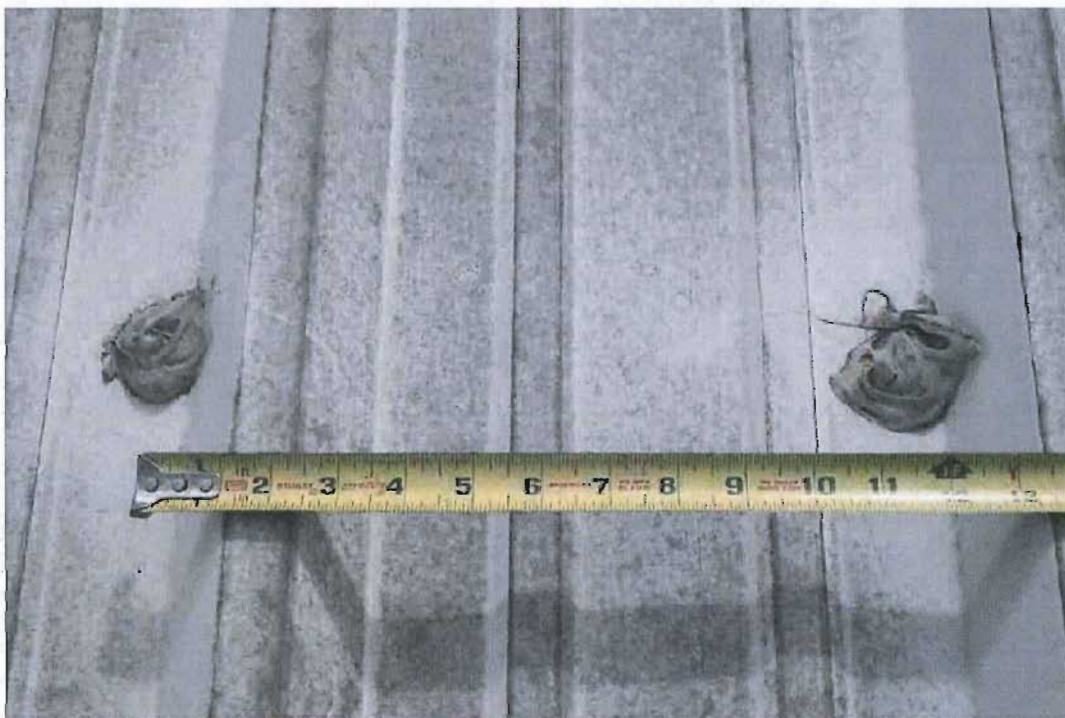
16. 4128 BLDG – Caulking applied to fasteners.

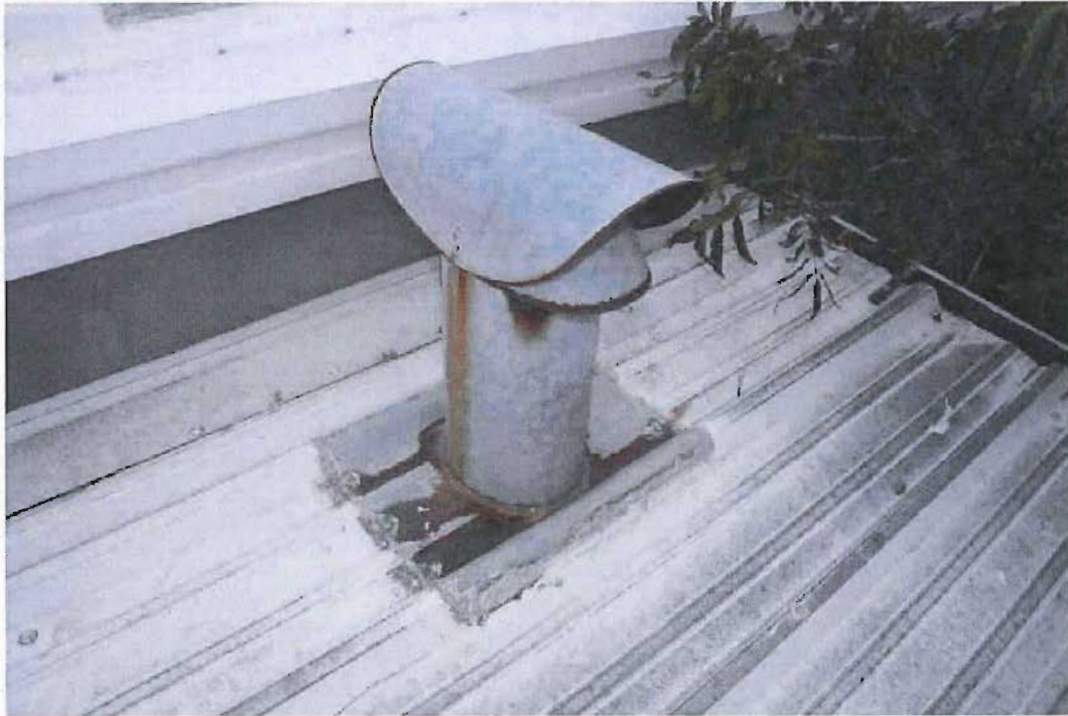
17. 4128 BLDG – Base flashing was not sealed correctly around vent.

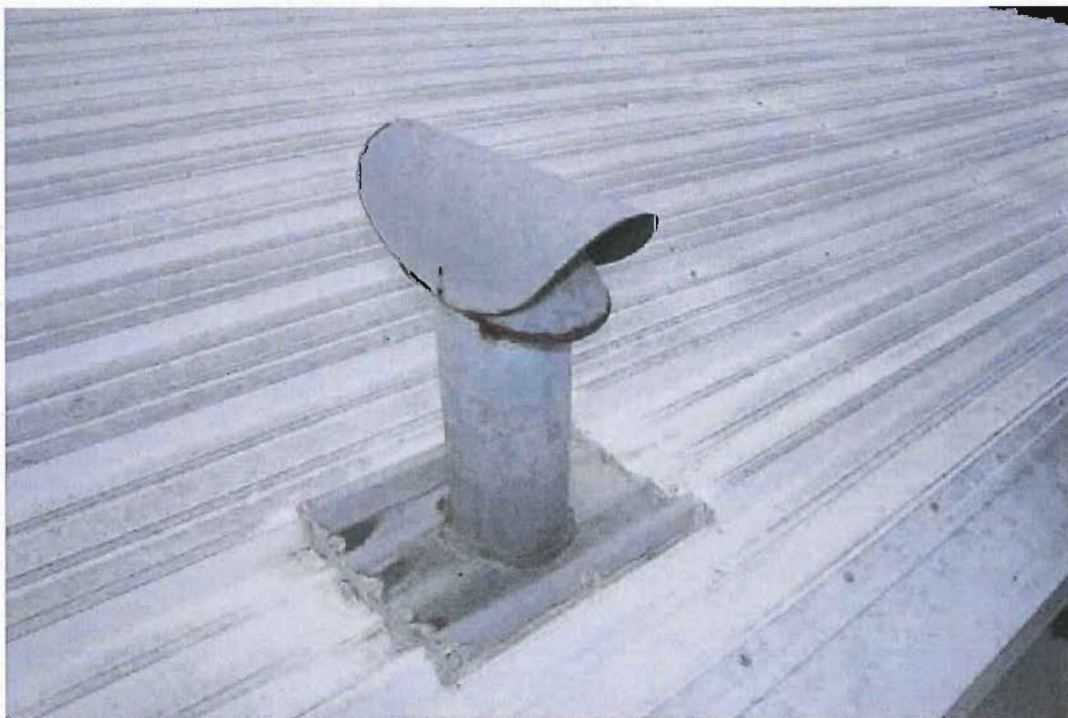
18. 4128 BLDG – Base flashing was not sealed correctly around vent.

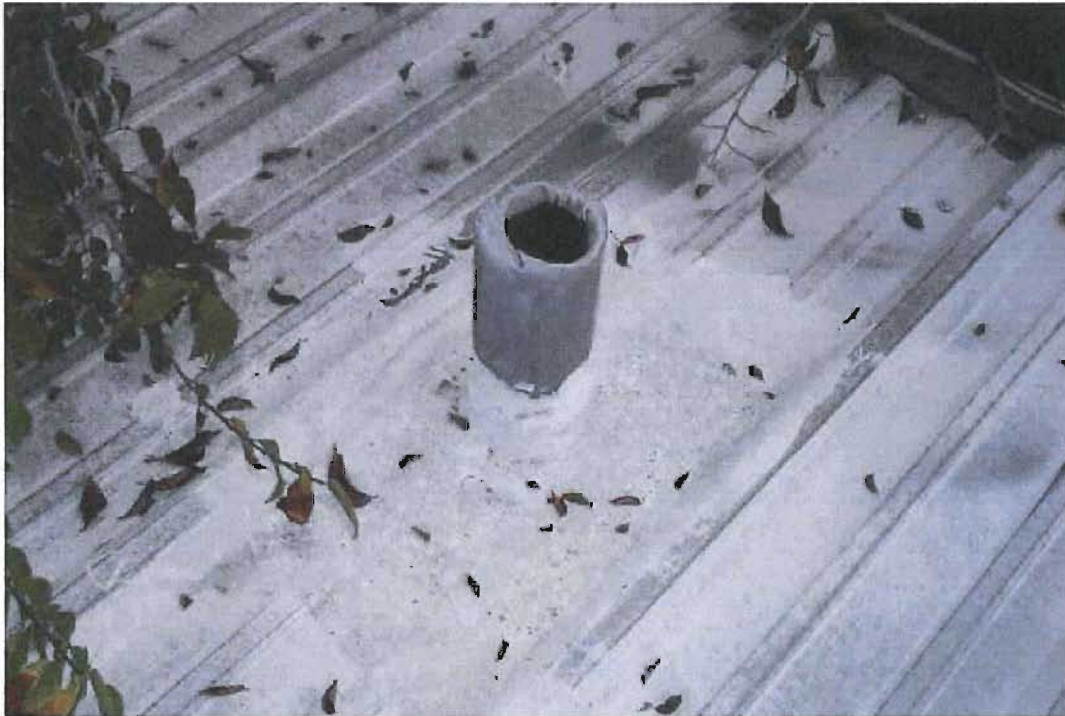
19. 4128 BLDG – Lead sleeve was not flashed correctly.

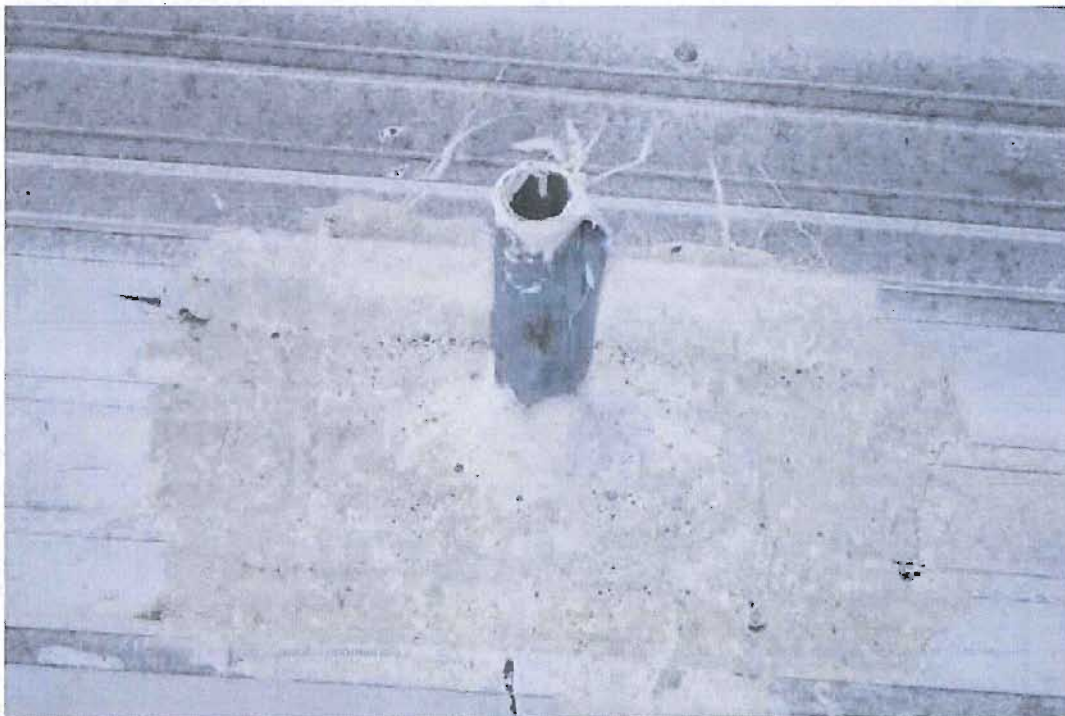
20. 4128 BLDG – Lead sleeve was not flashed correctly.

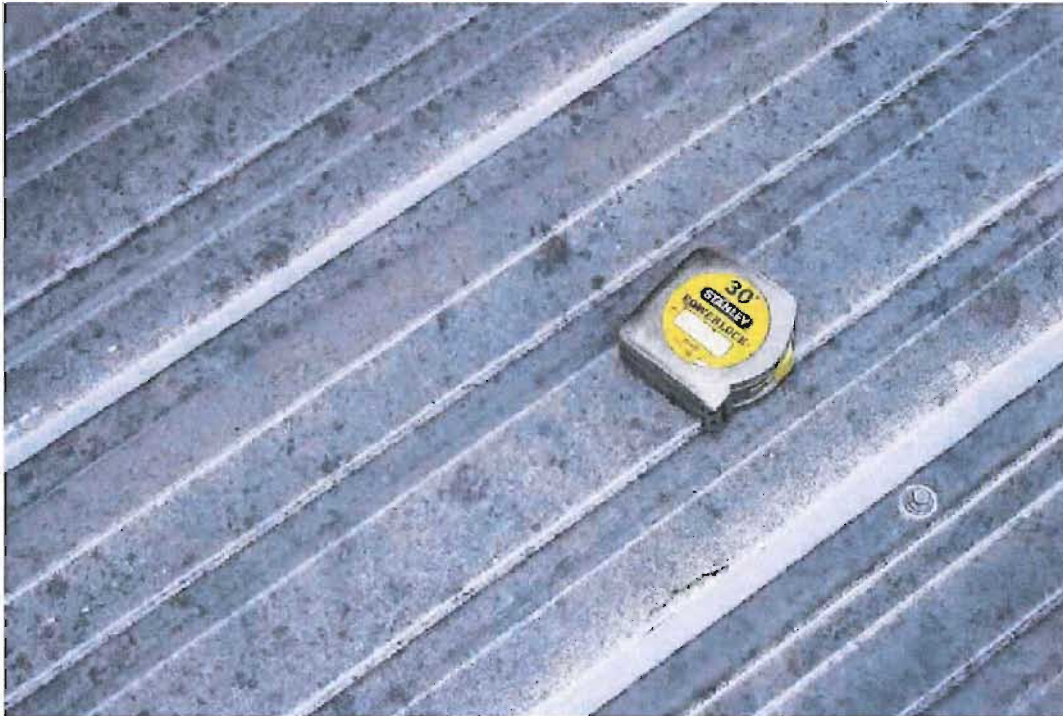
Hail had fallen recently at this location as noted by the spatter marks on the metal panels. The spatter marks were created when hail impacted and removed some of the dirt film and paint residue on the panel surfaces. Hail-caused spatter marks measured up to 1 inch in diameter. No hail-caused dents were found in the field panels. However, hail-caused dents were visible in the ridge caps. The dents were broad and shallow compared to the foot-caused crimps. Hail-caused dents measured up to 3/4 inch in diameter and were most visible when looking obliquely at the reflection of the sun or by rubbing the panel surfaces with chalk. The dents were not coincident with the hail-caused spatter marks, indicating these dents were caused by a prior hailstorm(s). (Refer to Photographs 21 through 26.)

21. 4128 BLDG – Hail-caused spatter marks on panels.

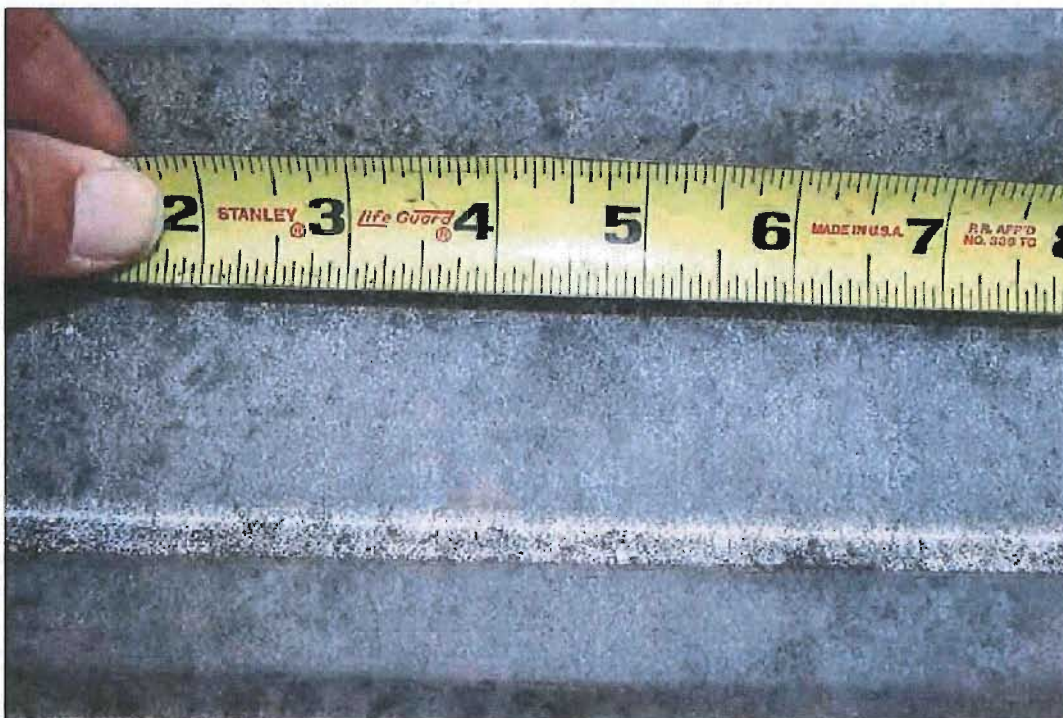
22. 4128 BLDG – Closer view of hail-caused spatter marks on panel.

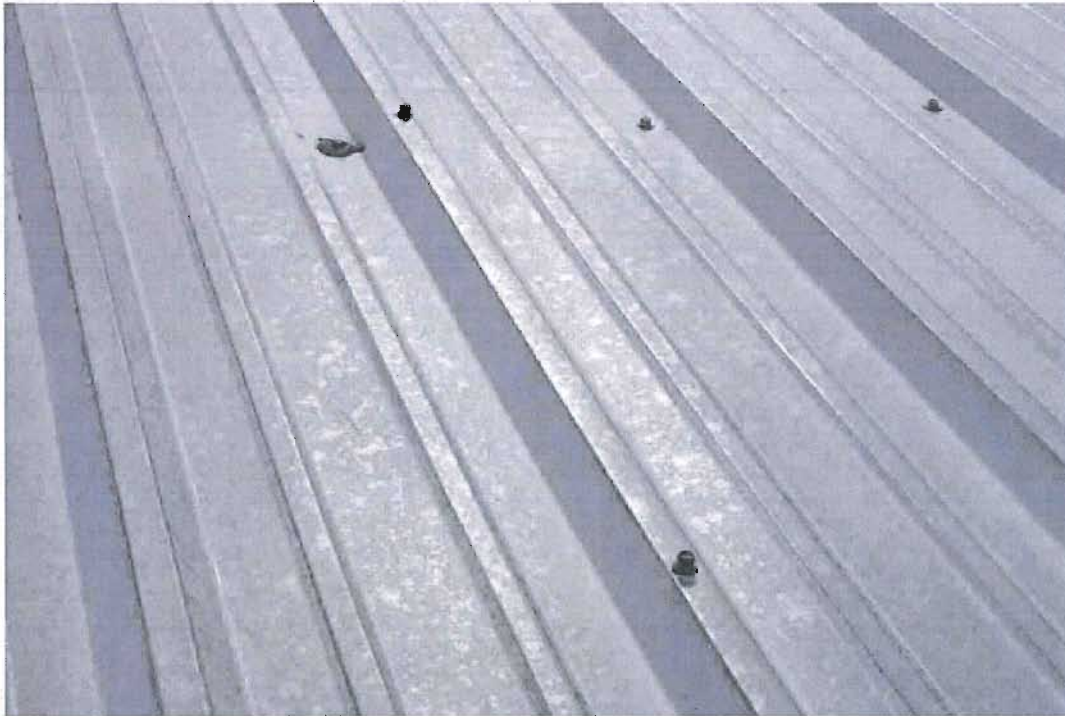
23. 4128 BLDG – Oblique view showing hail-caused spatter marks on panels.

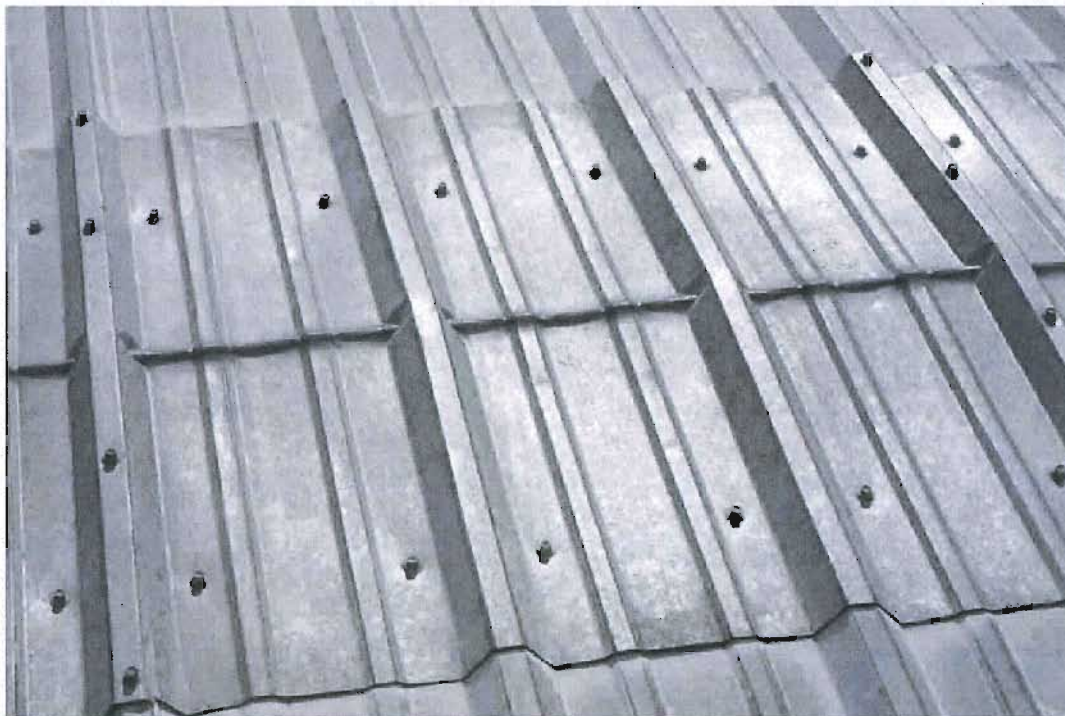
24. 4128 BLDG – Hail-caused dents in ridge cap.

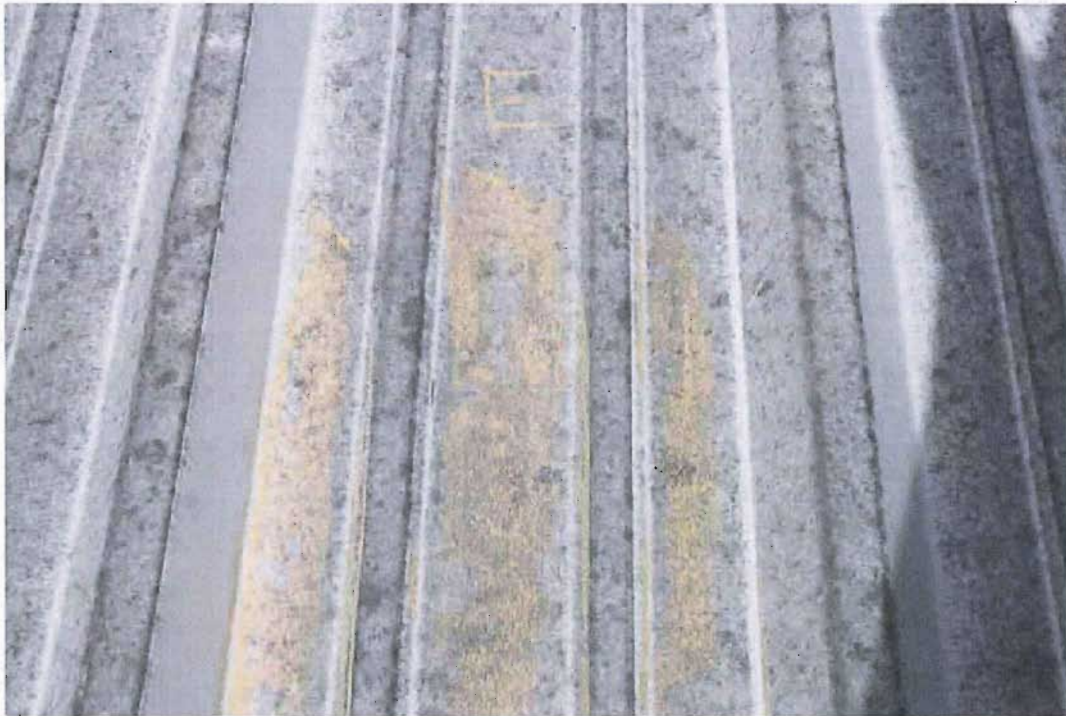
25. 4128 BLDG – Chalk rub on east panel revealed no hail-caused dents.

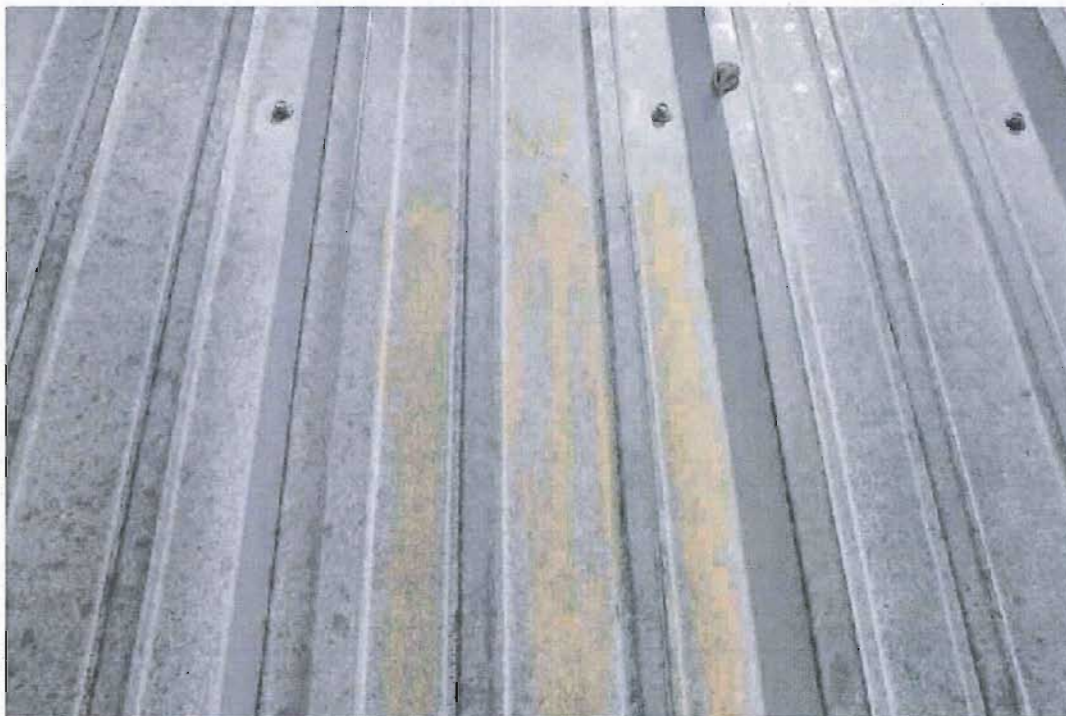
26. 4128 BLDG – Chalk rub on west panel revealed no hail-caused dents.

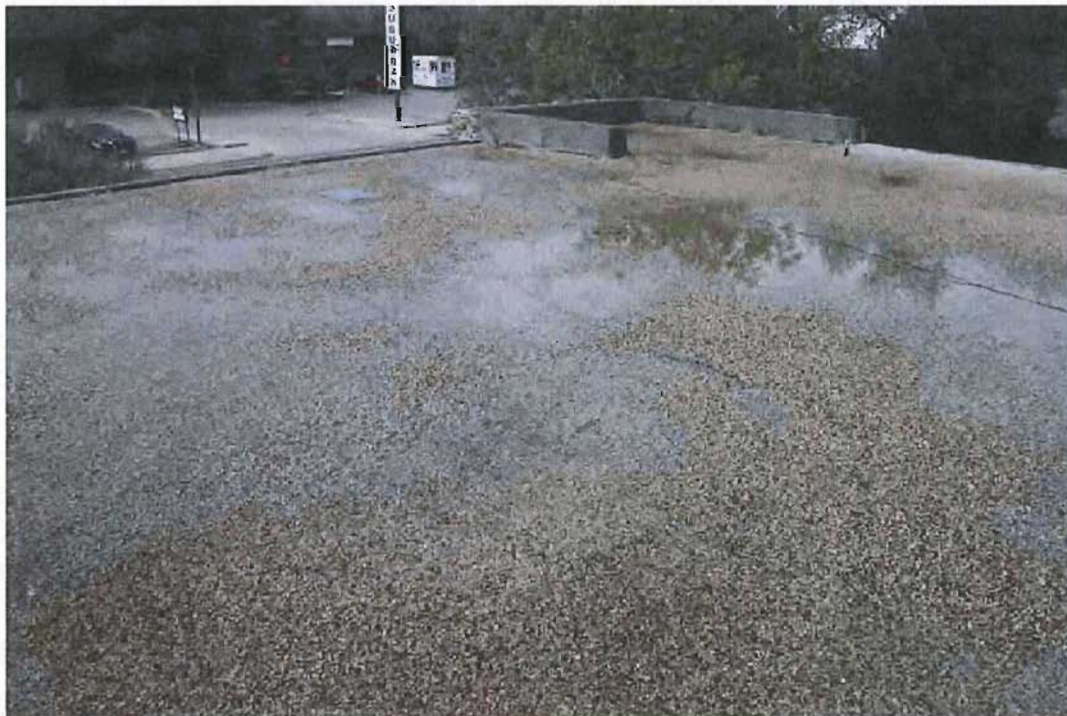
The built-up roof at this location was in good condition. The vast majority of the roof was covered with sufficient loose and embedded gravel. No blisters or wrinkles were detected in the membrane. However, there were isolated deficiencies inherent with this roof. Water had accumulated in low spots on the flat roof as well as upslope of curbs on the sloping roof. Roof drains were clogged with leaf debris. There were isolated bare spots in the roof where the asphalt flood coat was exposed to the weather. The exposed asphalt had oxidized and contained craze cracks ("alligatoring"). A white sealant had been applied to three of the plastic skylights. (Refer to Photographs 27 through 32.)

30. 4130 BLDG – Flat roof. Note ponded water.

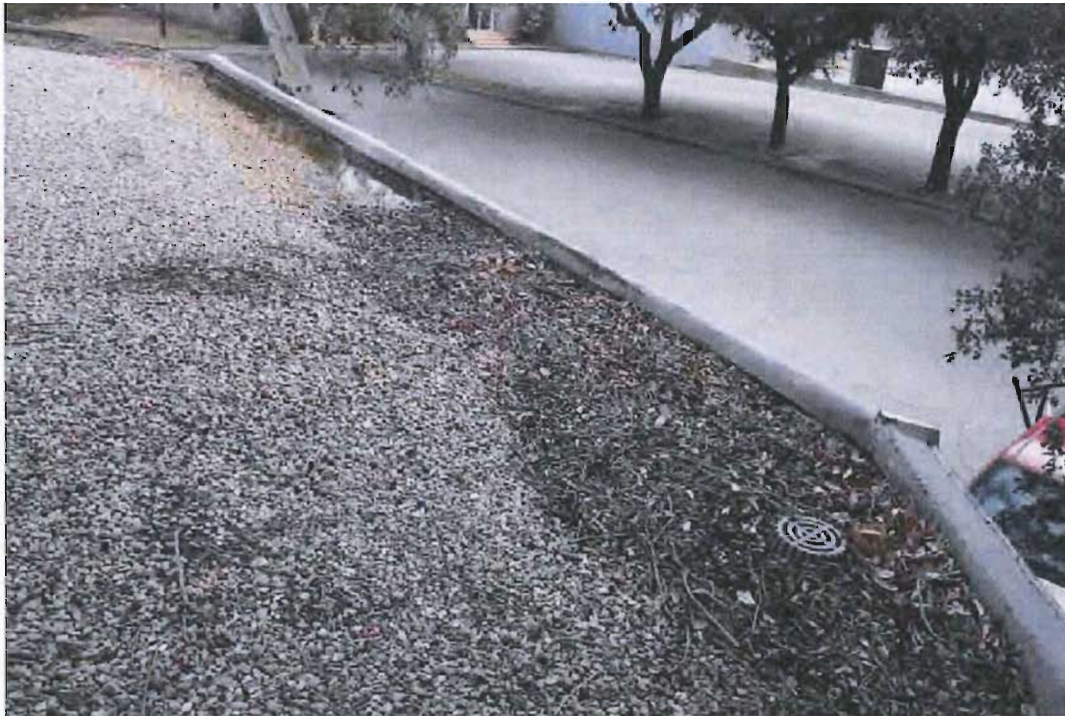
31. 4130 BLDG – Clogged roof drain.

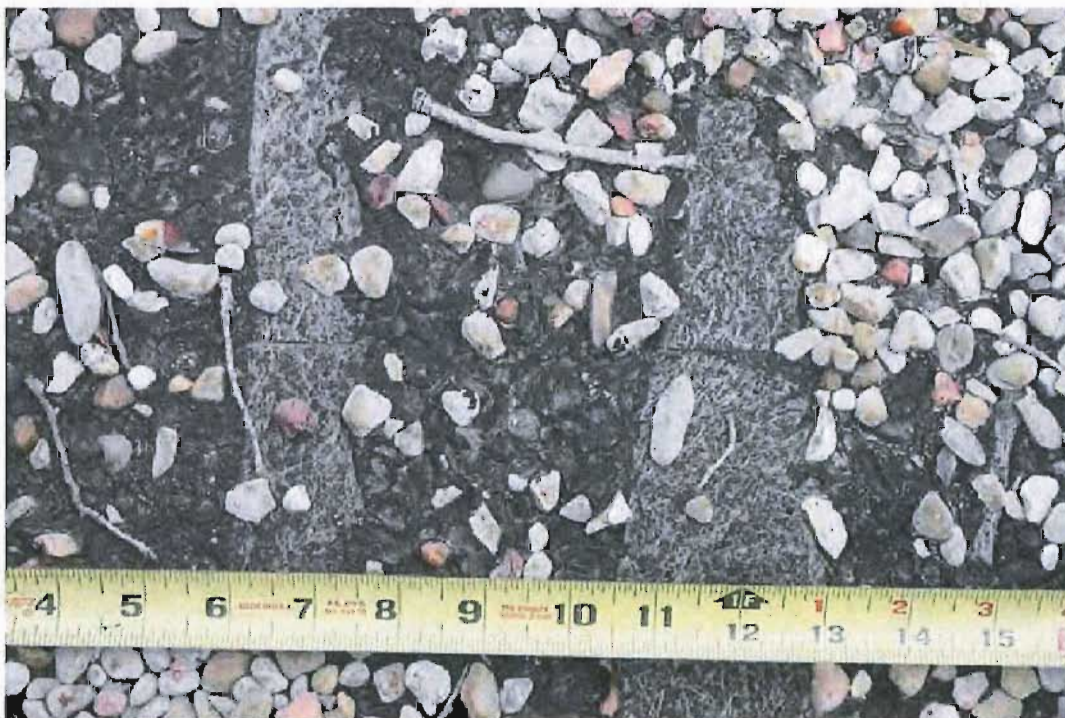
32. 4130 BLDG – Bare roof membrane.

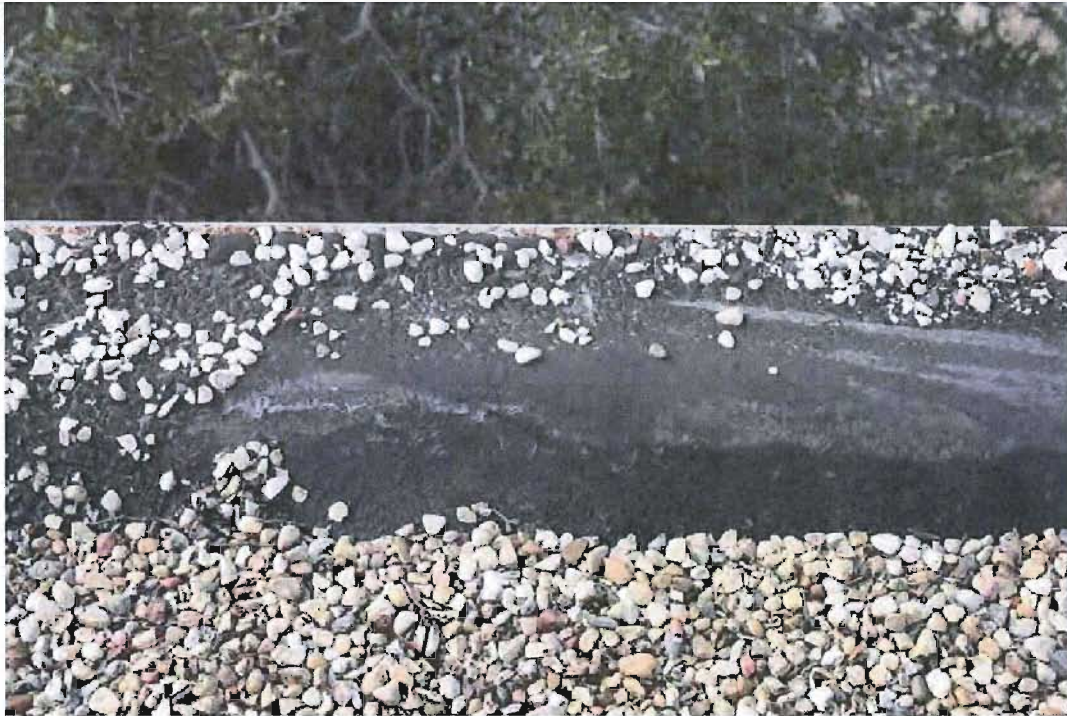
33. 4130 BLDG – Lack of hail damage to exposed curb.

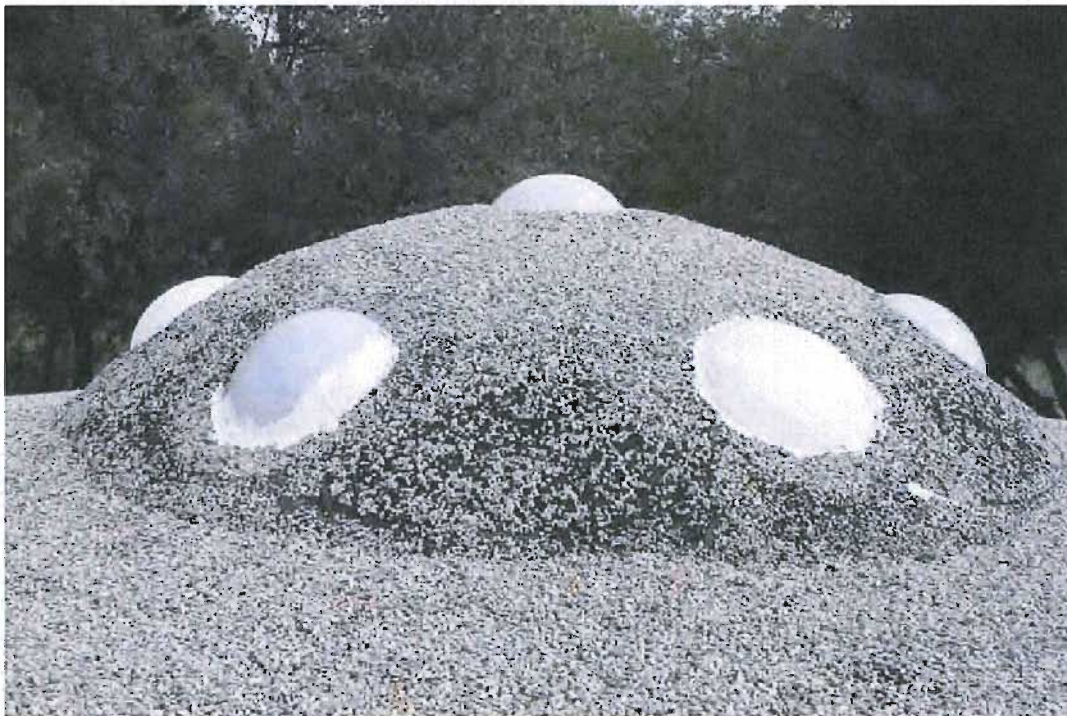
34. 4130 BLDG – Lack of hail damage to plastic skylights.

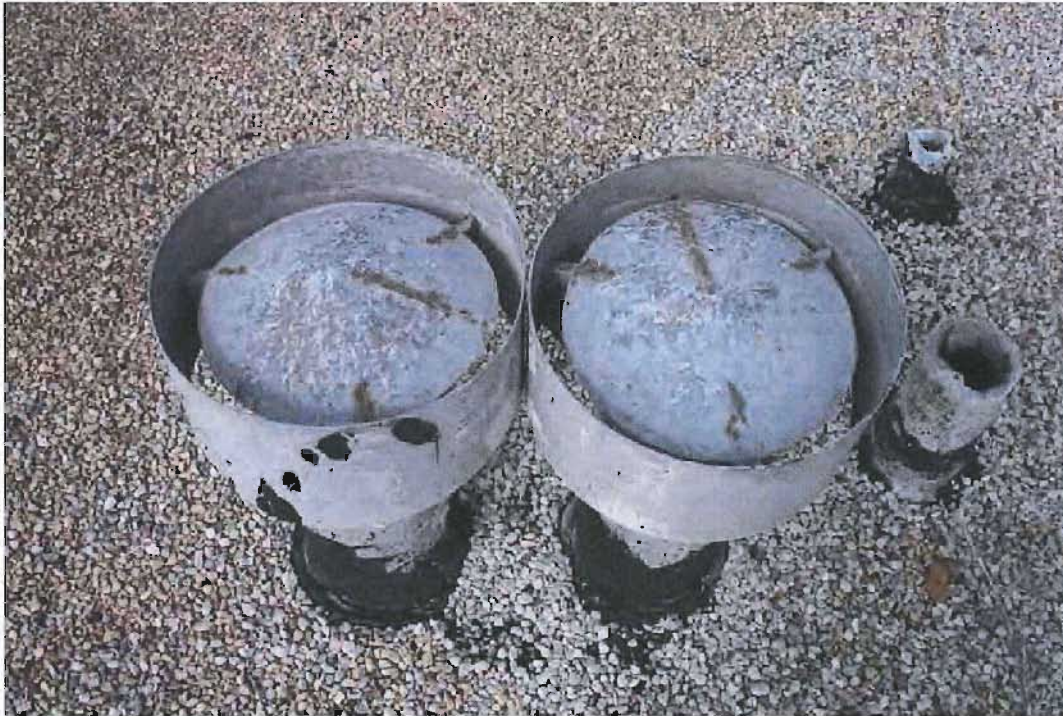
35. 4130 BLDG – No hail-caused dents in galvanized metal vents.
